Tech News

VAG 0B5

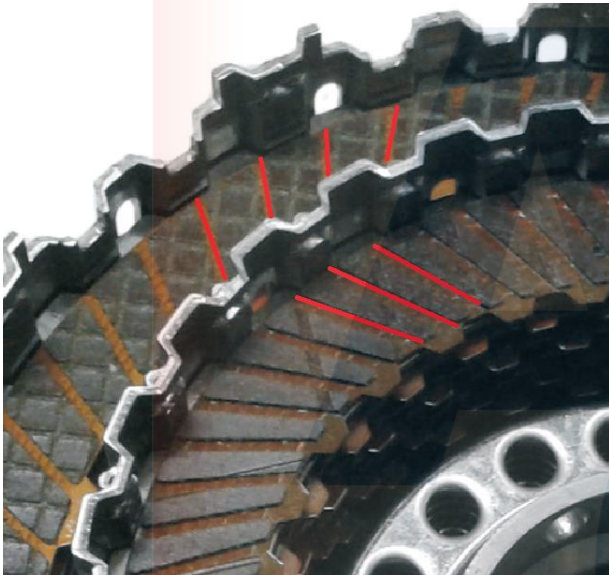
Correct direction of both plates:
