# ZF 6HP19A

## TECHNICAL INFORMATION BULLETIN

# ZF 6HP19 & 6HP19A Fitted to BMW, VW & Audi

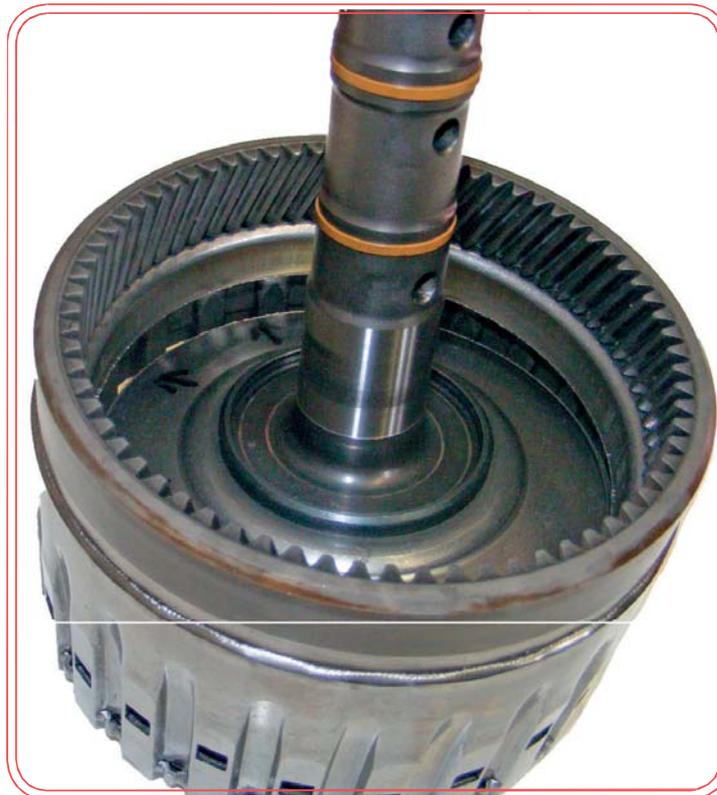
Flare into fourth, no upshift into fourth, if throttle is released the transmission engages fourth OK and once in fourth will drive without problem on all throttle settings.

It not uncommon for the 'E' clutch drum assembly to crack around the inner circumference of 'E' clutch piston bore, this can be seen more readily from the annulus side of the drum as shown in the illustration below. We believe this is due to the constant flexing at this point caused by the planetary sun gears driving the annulus back and fourth during drive and overrun conditions, this gradually over time creates a stress fracture. The reason that once fourth has engaged all seems well is that when the throttle is released the annulus is drawn forward on overrun, closing the crack and allowing pressure to build up behind the piston, this pressure then further reinforces the closure of the crack keeping the clutch fully engaged, giving the impression that all is now well within the clutch.

In this illustration the crack has been opened up to emphasise the area to examine, it is quite often very difficult to see, so very careful examination is necessary

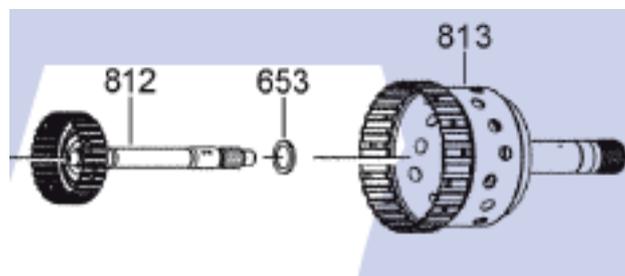
### 6HP19.HUB01 Modified Intermediate Shaft

Models built after 01/2005 have received an update, which is our part number 6HP19.HUB01. This update was implemented because the hub was found to have a weakness which often resulted in premature failure. The material of the shaft was too thin, and has been replaced with a more substantial shaft on the current #812 hub (6HP19.HUB01).

This means that 6HP19A units (for example 1071 040 020) built before 01/2005 may have the old style hub, which can't be purchased from ZF any more. However, the old version can be updated to the modified units, by also changing the sun gear shaft #813 (6HP19.HUB02) and the sun gear shaft to intermediate shaft radial bearing #653 (6HP19.TOR02).

In a nutshell, if you have a 6HP19A unit built before 01/2005 with a damaged intermediate shaft #812, it may require sun gear shaft #813 and radial bearing #653 to make everything fit back together correctly.
