Pump Rebuild Kit

K74878

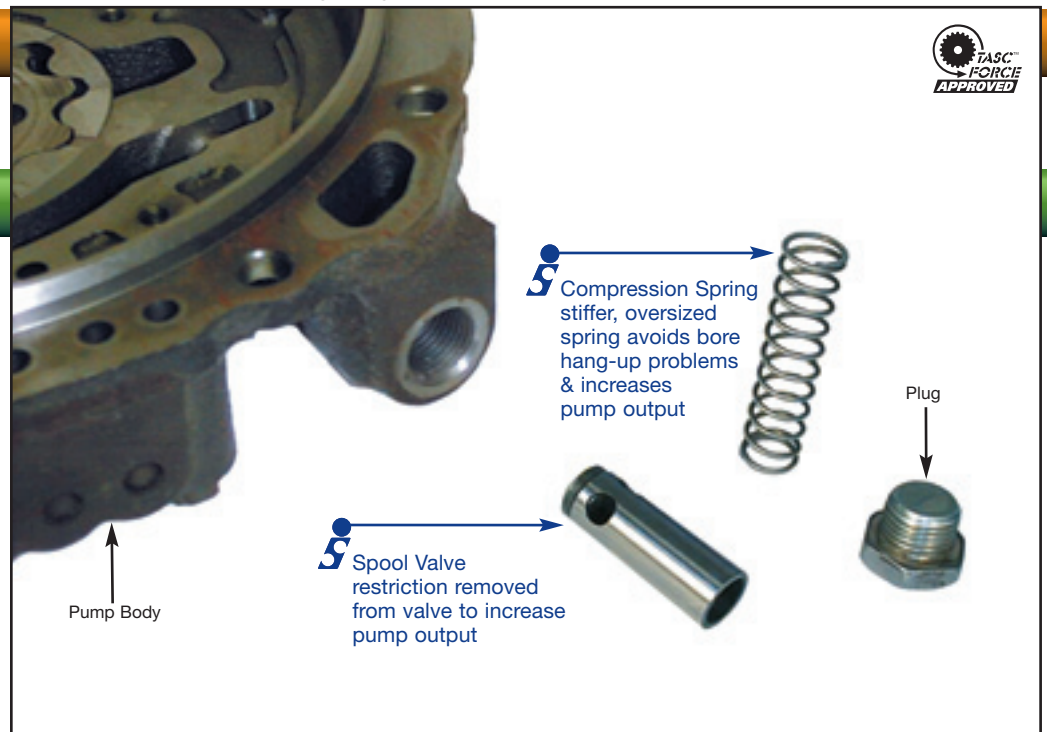
2-3 shift flare

- Low pump output • Spring hang-up problems

Insufficient pump flow to pressure regulator valve.

In the F4A-EL & GF4A-EL transmissions, when pump volume is too low, it causes low line pressure, which results in a 2-3 shift flare. Frequently these problems can be traced back to the pump's inability to flow oil to the pressure regulator. All pump volume flows through the spool valve to the regulator in the valve body. This spool valve position determines pump volume by overcoming the spring and exhausting output to suction. Sonnax has developed a pump rebuild kit K74878 for the F4A-EL & GF4A-EL pumps.

This pump rebuild kit includes a replacement spool valve with a specially designed I.D. that reduces restrictions and a specially designed and stiffer spring to avoid bore hang-ups and improve pump volume.

- 1 Spool Valve
- 1 Compression Spring

Note: Fits 1-pan style unit and 2-pan, 7-solenoid style units with gear pumps.
